REVIEW OF PARCEL ED-1
Under Section 120 (h) of the
Comprehensive Environmental Response, Compensation, and Liability Act
and Section XLIII of the Federal Facility Agreement
August 11, 1995

Executive Summary

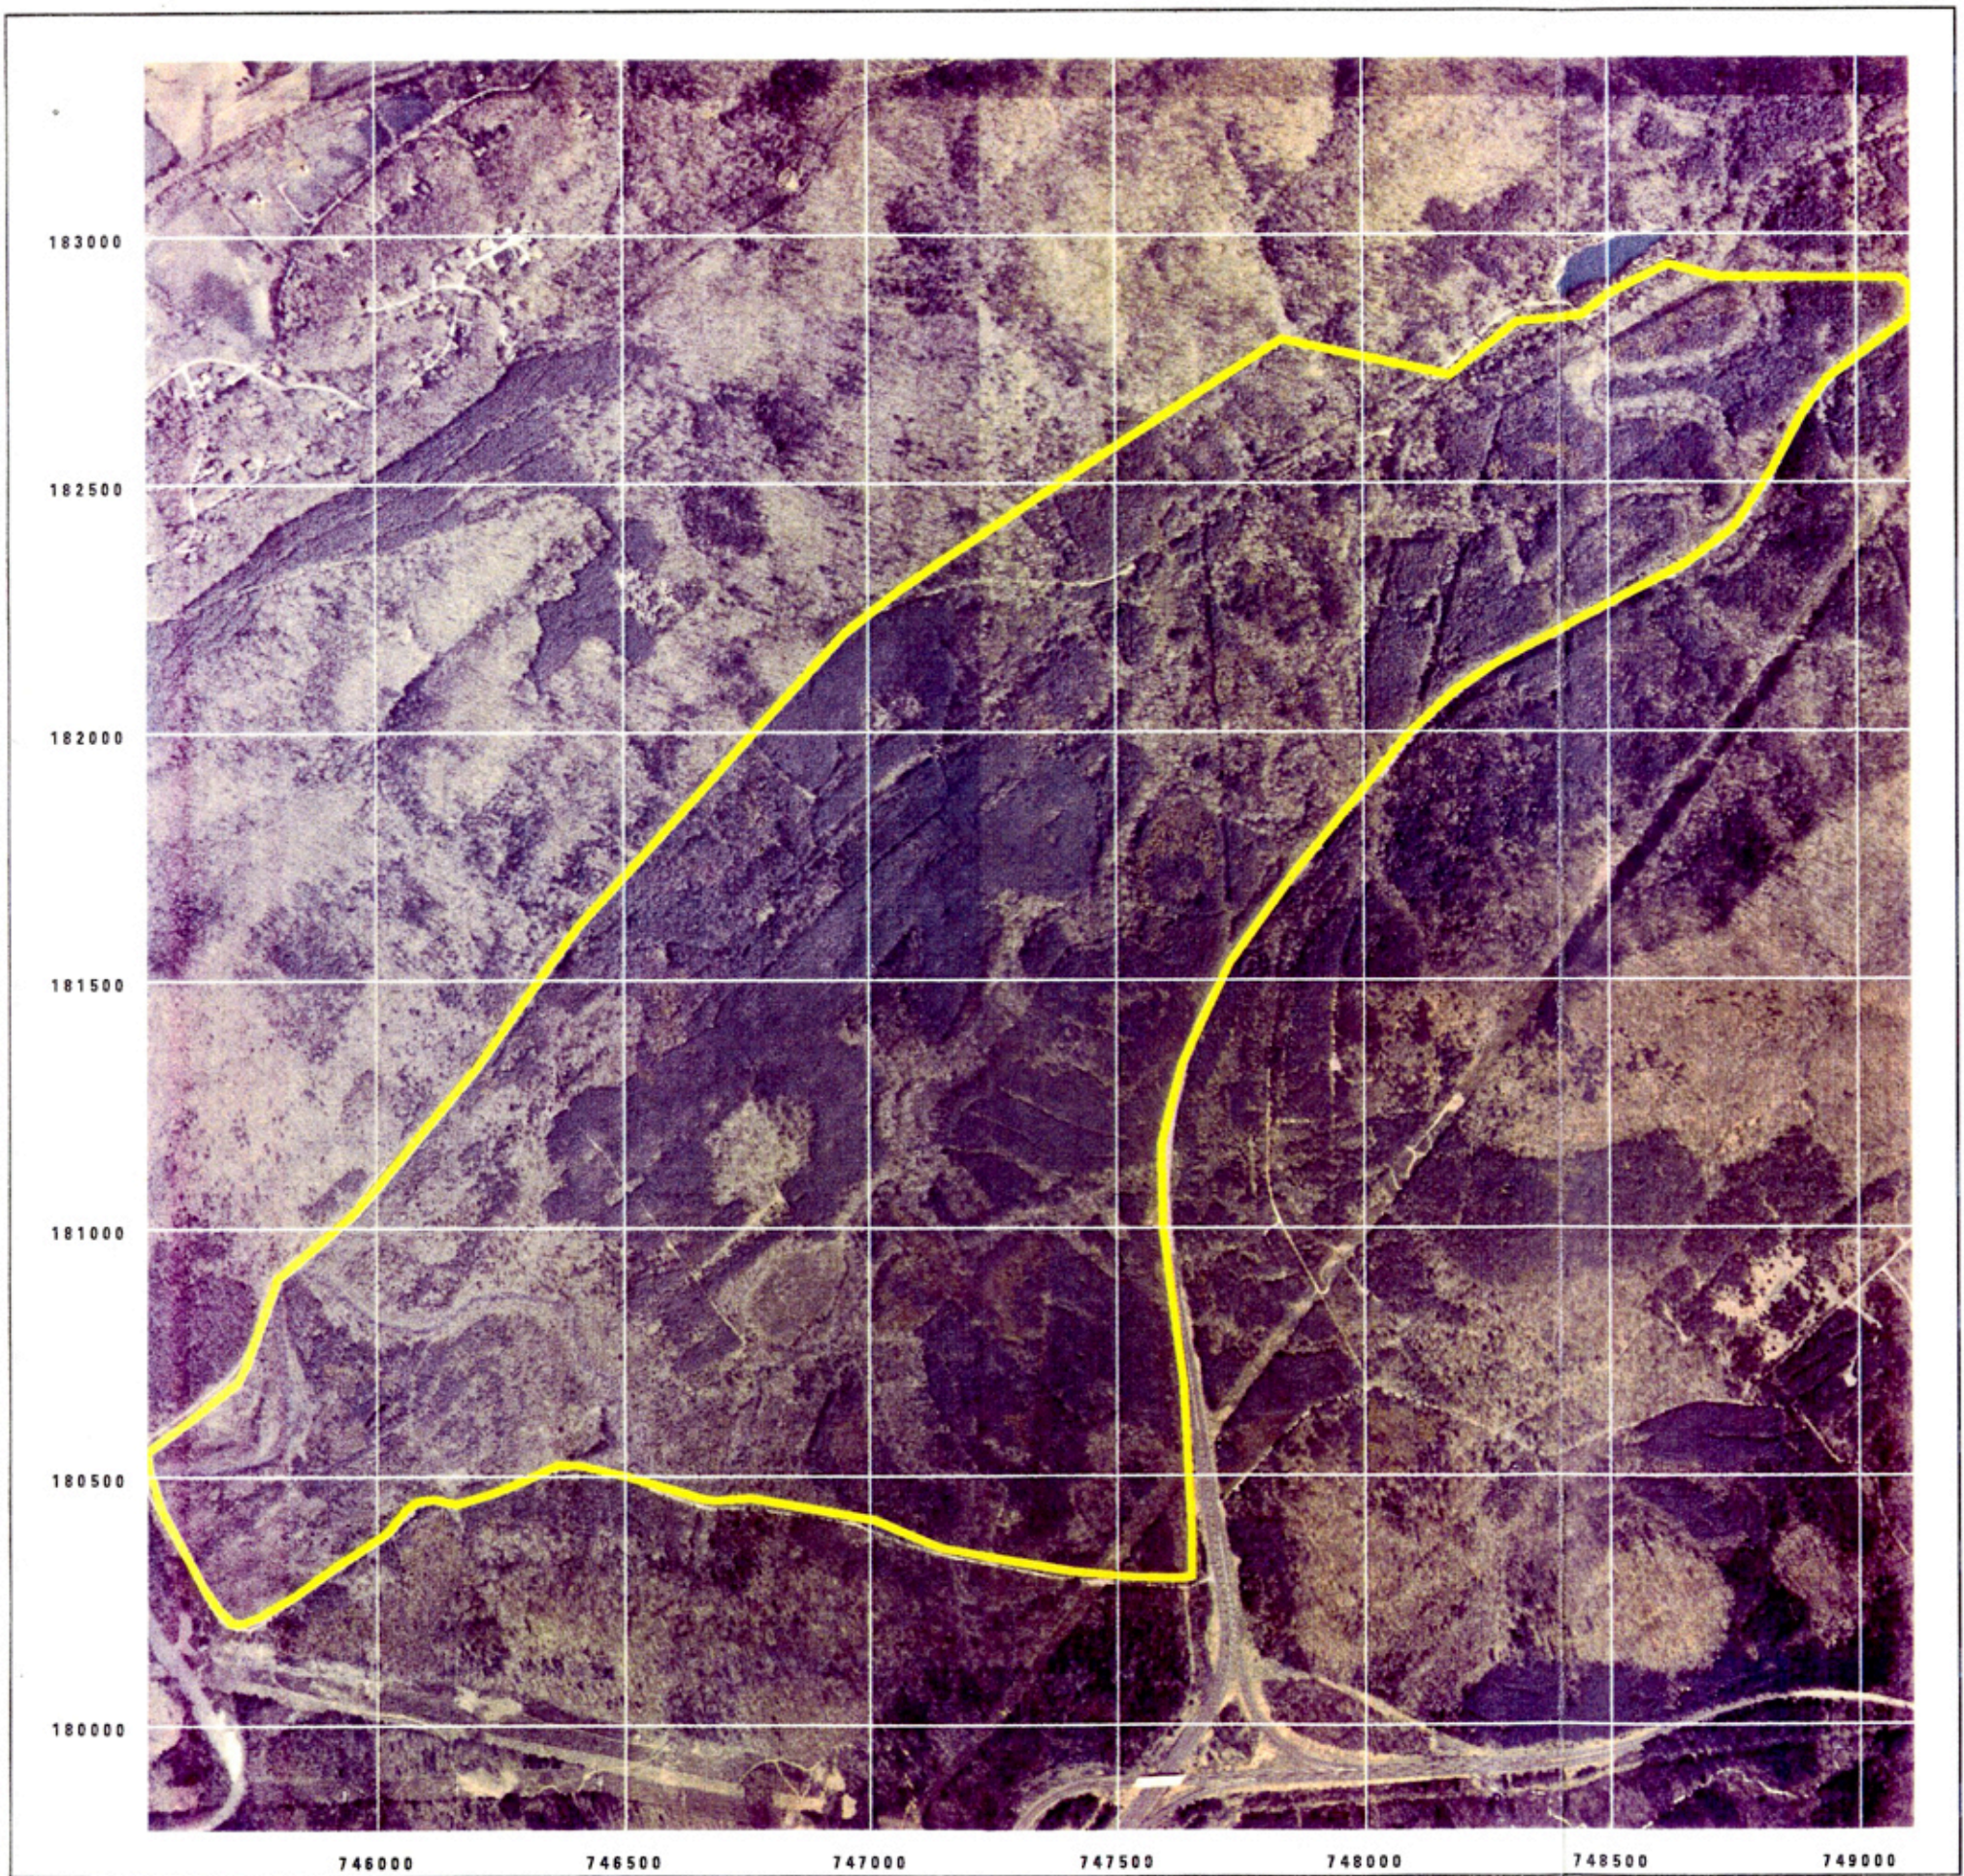
Ortho Image of Parcel ED-1

- Aerial Photography Taken April 9 & 10, 1993.
- Aerial Photography Scale 1:14,400.
- 500 m. NAD 83 Tennessee State Plane Grid Shown.
- Map created: August 10, 1995.

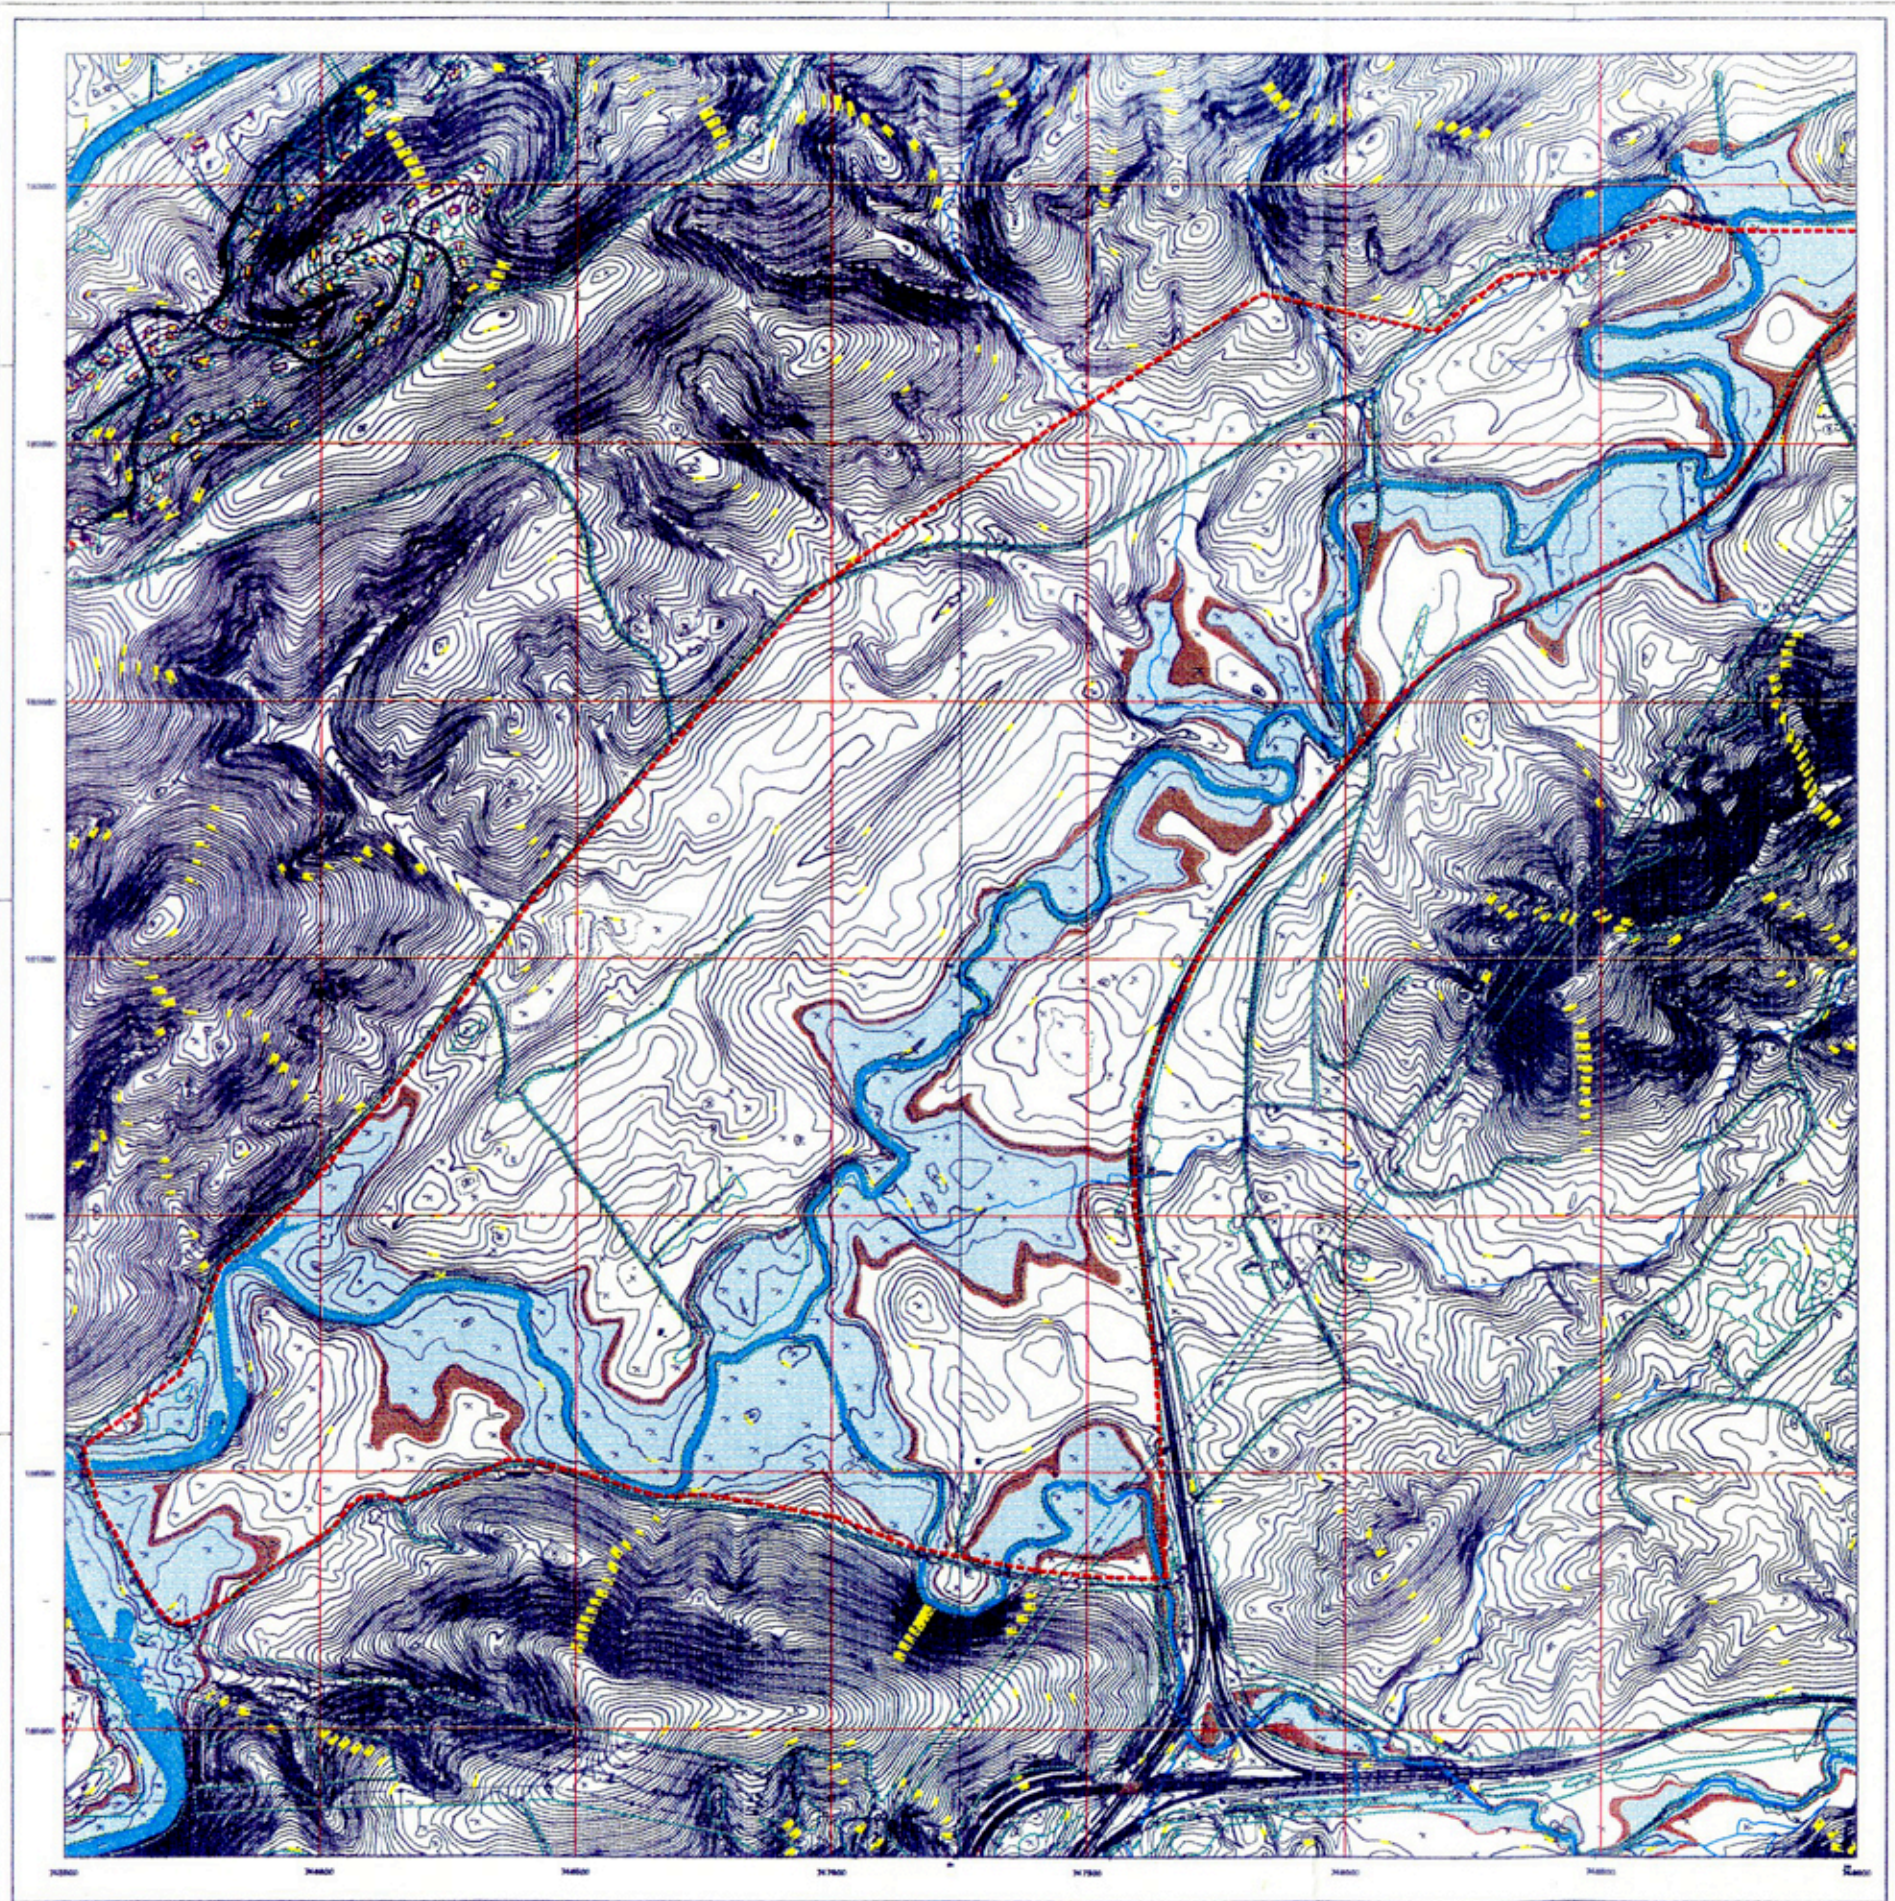
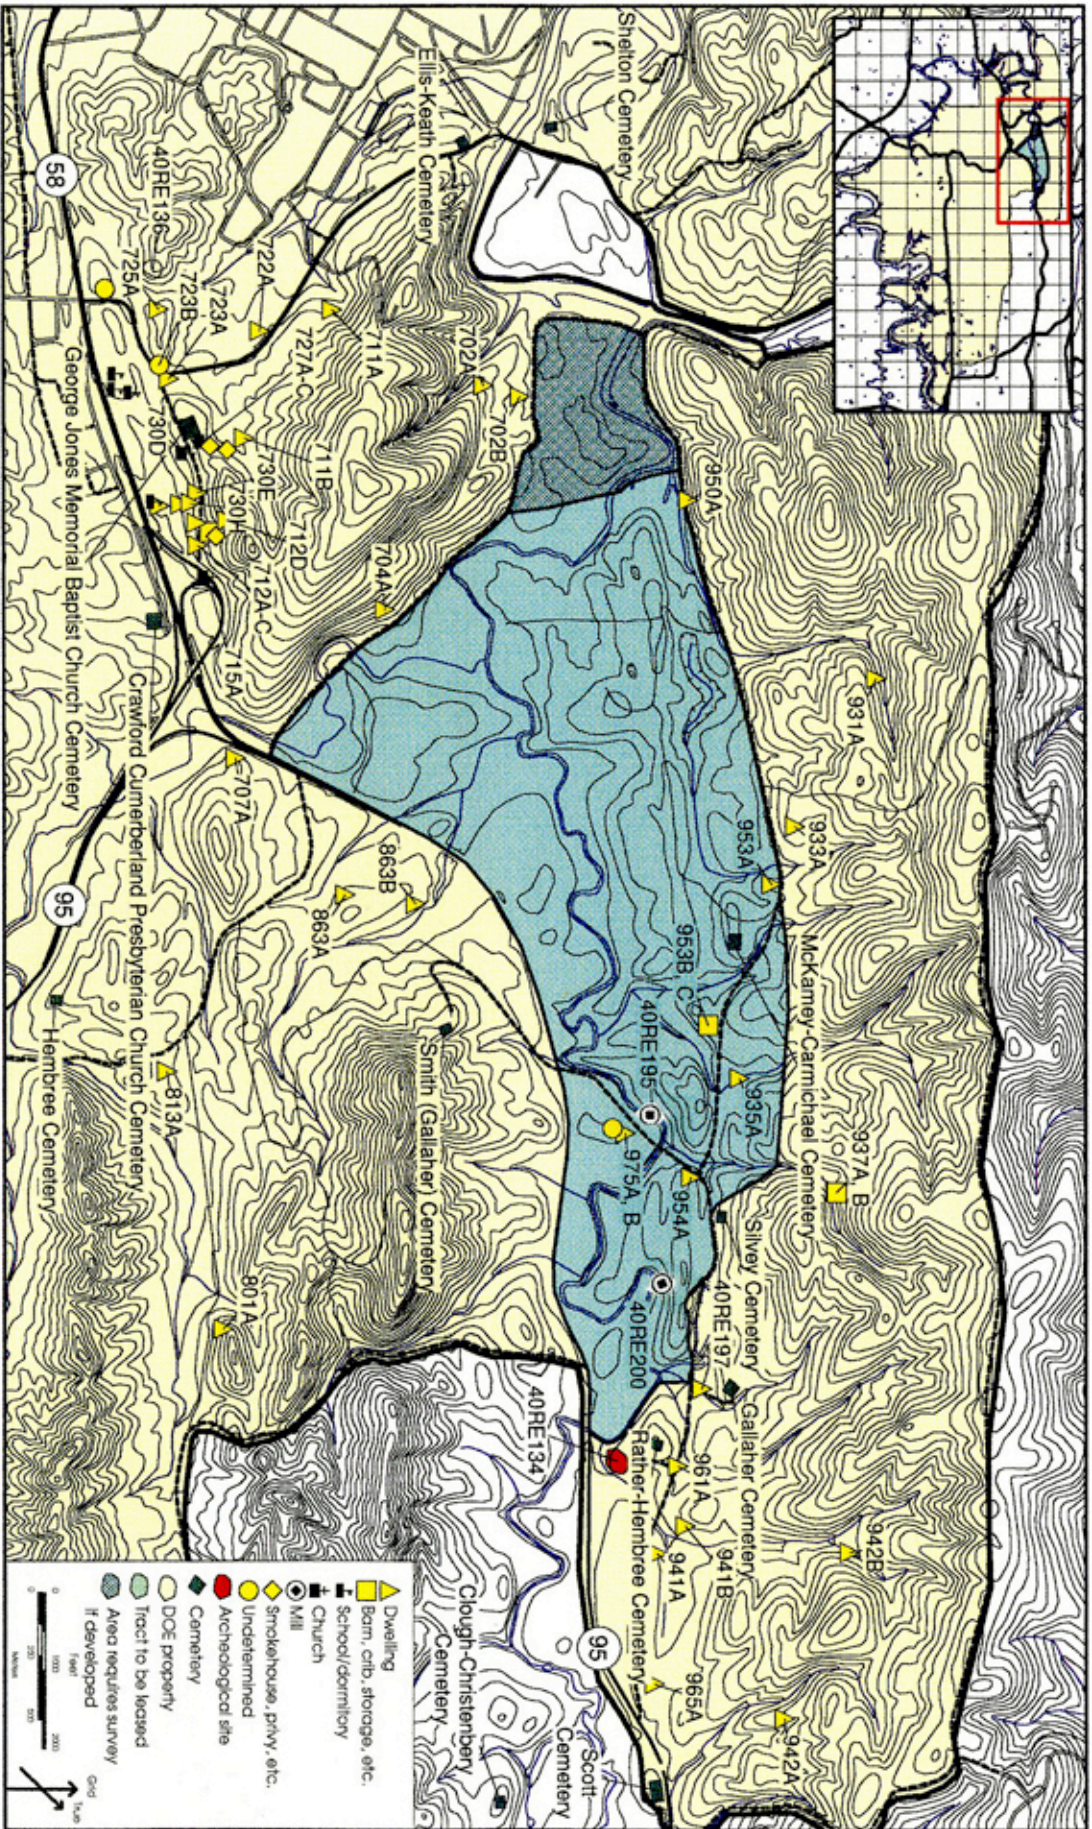
Figure B-2. Location of pre-World War II structures, archaeological sites, and cemeteries within and adjacent to the tract.

A cemetery exists within the parcel. In addition, evidence of several farm sites, inhabited before the purchase of land by the federal government for the Manhattan Project, exists in several locations on the parcel. Figure B-2 in Appendix B shows the locations of the cemetery, pre-World War II structures, and archaeological sites. No tanks or remnants of tanks have been observed by those conducting research or normal work activities on the property. No record of leakage or spillage from any residential/farm tanks has been documented in the records reviewed during this investigation.

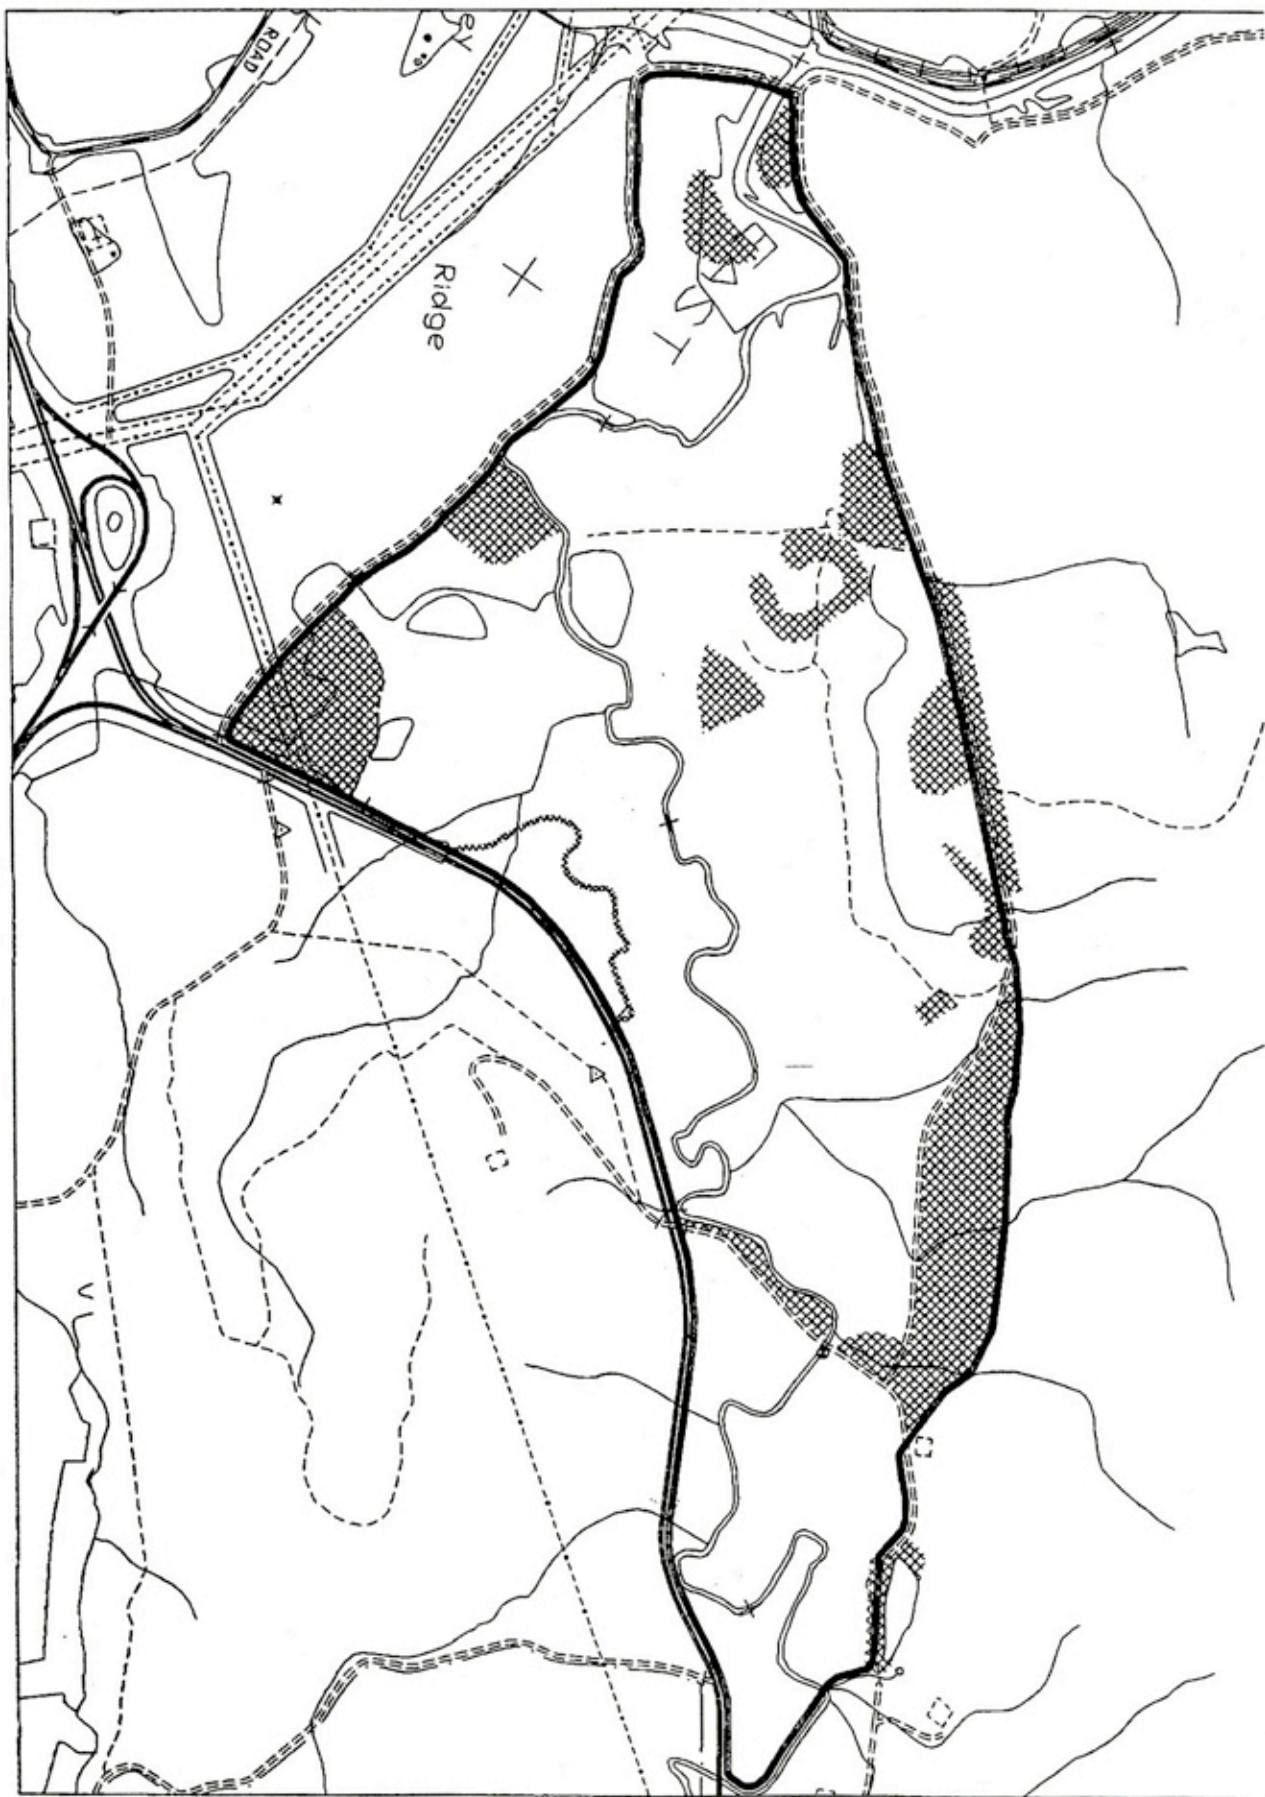
Figure B-3. Radiological characterization survey: areas surveyed

A radiological characterization survey was conducted for this report by a team from the Measurement Applications and Development (MAD) Group at Oak Ridge National Laboratory (ORNL). The survey conducted by the MAD Group consisted of a radiation measurement survey of the ground surface in areas accessible to the survey team. The gamma radiation levels were determined using portable NaI gamma scintillation meters. Systematic surface (0–15 cm) soil samples were collected in selected locations without regard to radiation levels. Survey plans included analyzing all samples in the laboratory by gamma spectroscopy to determine concentrations of ^{238}U , and ^{226}Ra as well as any other gamma-emitting nuclide. The survey covered 13 discrete areas encompassing about 100 acres as shown in Figure B-3. The survey also included all roads shown on Figure B-4. Except for areas within the East Fork Poplar Creek floodplain, all gamma exposure rates were less than 10 uR/hr, typical of the natural background radiation in this area of the Oak Ridge Reservation. The results of radiological analysis of soil samples revealed concentrations of ^{238}U ranging up to 2.8 pCi/g. Concentrations of ^{226}Ra were found as high as 1.1 pCi/g. Figure B-4 shows soil sampling locations. All results are typical of radionuclide concentrations found in uncontaminated locations in the area. For many of the samples, the ^{238}U activity was twice the ^{226}Ra activity, suggesting some aerial deposition of uranium. A similar radiological characterization of the area conducted by ORNL's Radiological Survey Activities Group in 1985 revealed no radiation levels above typical background for the area.

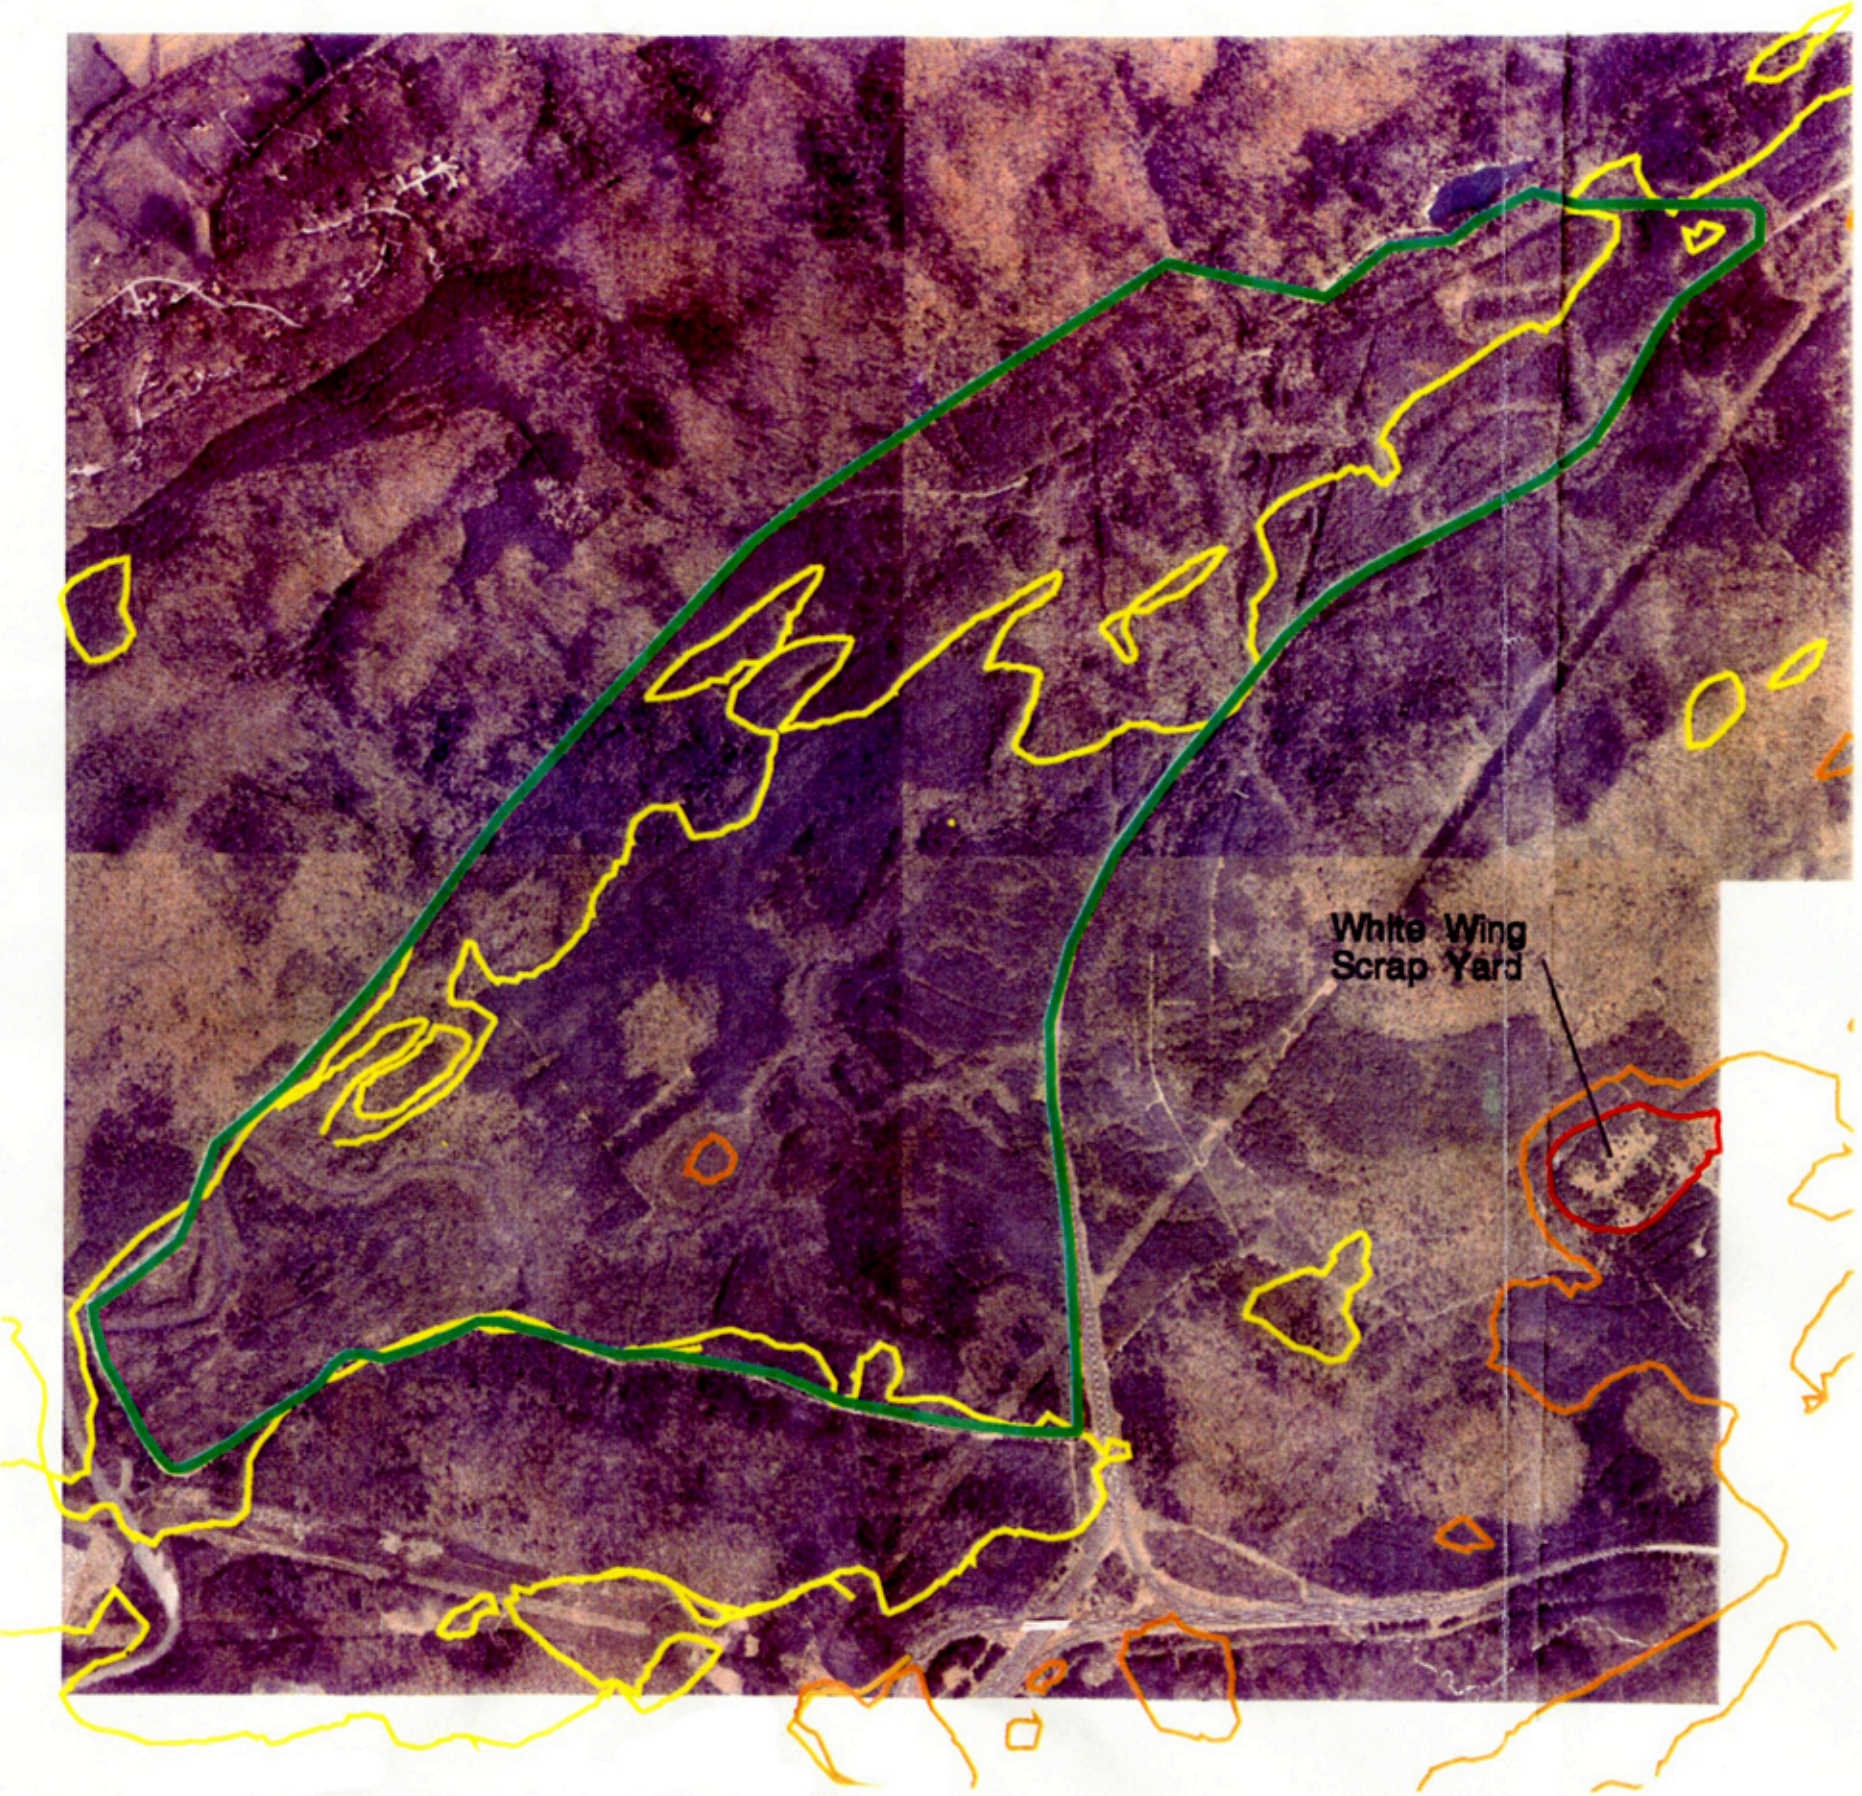
Figure C-3 Aerial Radiological Survey: Total Gamma Emissions (Naturally occurring and man-made sources)

These results are comparable to the results of the aerial survey conducted by EG&G (EG&G 1993). The EG&G survey showed no radiological anomalies in the parcel. Figures C-3 and C-4 show the results of aerial radiological surveys of total gamma emissions and man-made gamma emissions, respectively.
