ENVIRONMENTAL RESTORATION FOOTPRINT REDUCTION PROCESS

EVALUATION OF GALLAHER BEND/BULL BLUFF PARCEL

**Environmental Restoration
Footprint Reduction Process**

Evaluation of Gallaher Bend/Bull Bluff Parcel

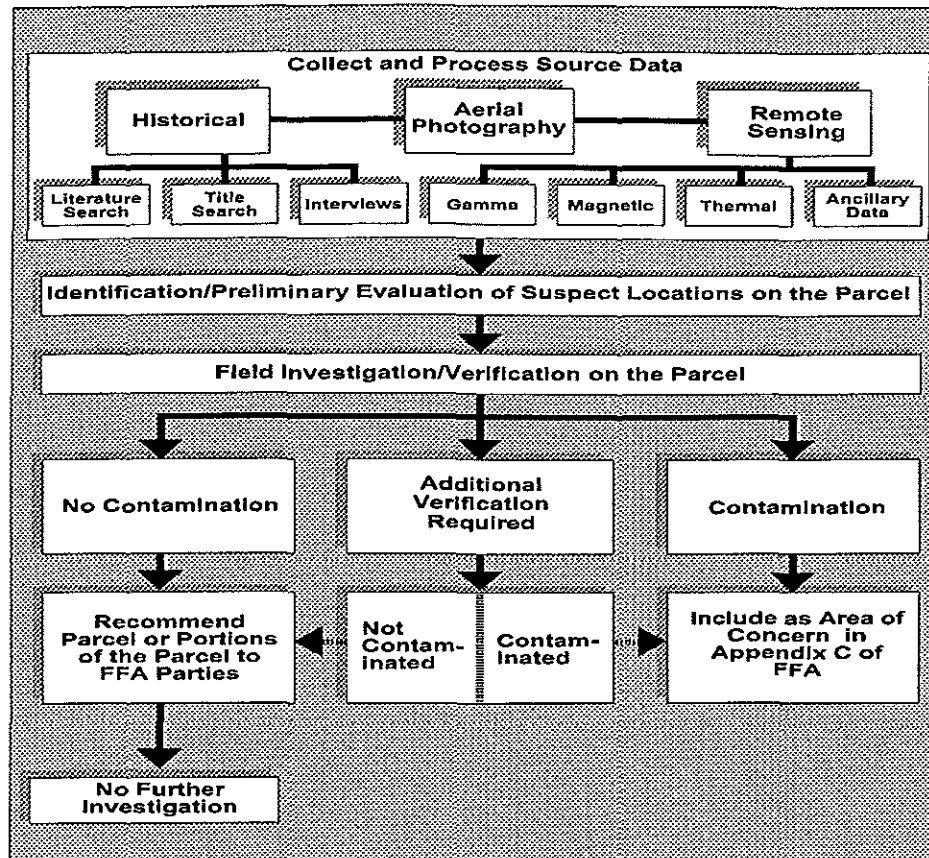
Fig. 2. Process Flowchart

sensed gamma surveys. Sources to identify landscape anomalies included remotely sensed vertical magnetic gradient, thermal imagery, and aerial photography. Supportive indicators of possible contamination are ancillary data that do not directly indicate an anomaly but which, in conjunction with other data, support the anomaly identification (e.g., topography, geology, and the location of historical sites) (see Fig. 2).

The second stage in the process was to map and evaluate the potential contaminated sites and landscape anomalies. For sites with potential contamination, the following questions were addressed: What is the severity of contamination (in relation to background levels), and if contamination is adjacent to the parcel, what is the potential for the parcel to be impacted? For landscape anomalies, the following questions were addressed: What cultural or physical processes created each anomaly, when did they occur, and do the causal processes suggest contamination?

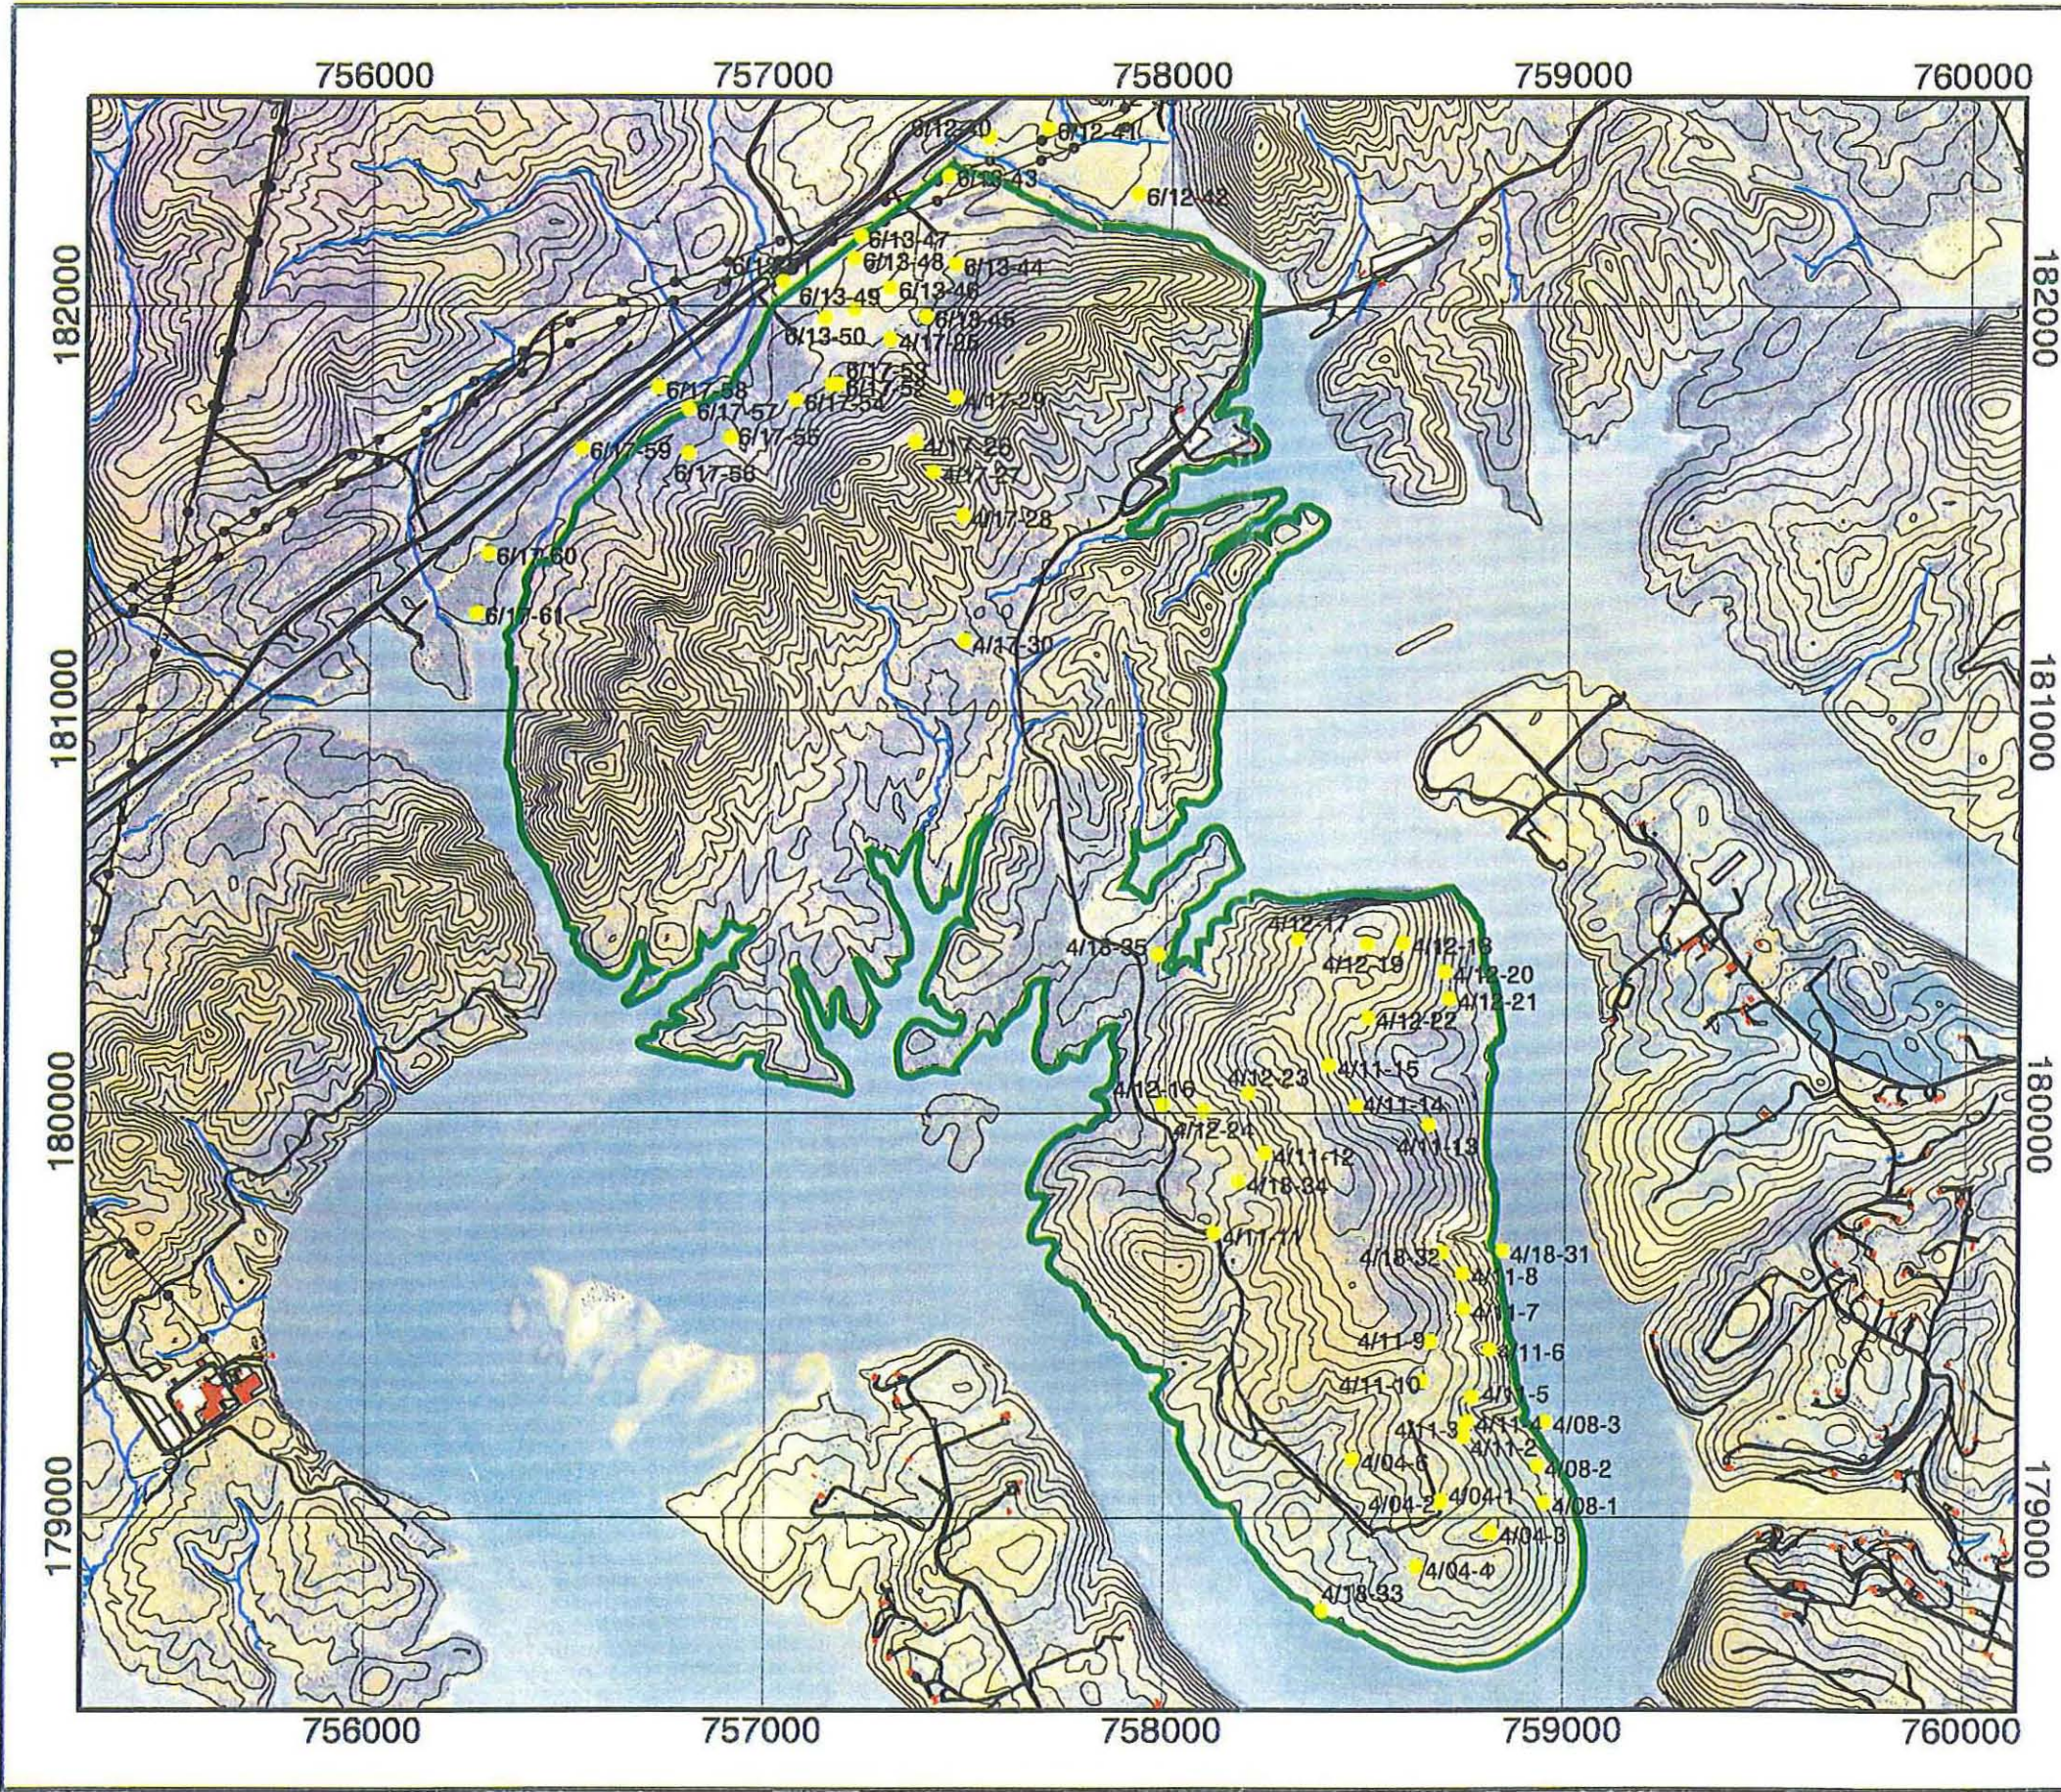
**Fig. 7
Surveyed Sites**

Summary of Field Investigation/Verification Findings. All of the mapped anomalies were attributed to prior dwellings or changes in geology or soil type, and there were no observable negative environmental impacts to the parcel from any prior or present activities
